**Flood Control Project Maintenance
Levee Inspections**

2018 Channel Summary Report

Merced Streams Group

Levee Inspection Report By Mile - Channel 2018

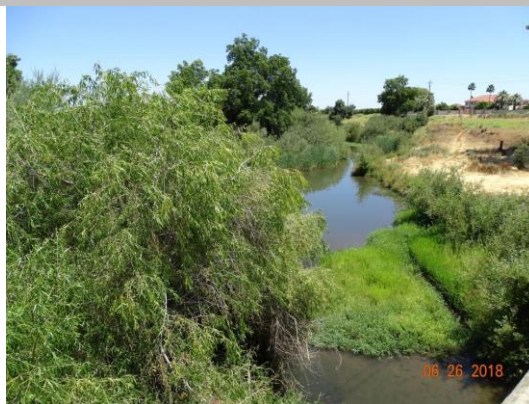
Photo 1 of 3 : CH_2018_NA0013_32_21_20180709_00027.jpg

Inspector Comments: There is growth in the channel and vegetation on the left bank upstream of crossing. Recommend clearing vegetation at least 100ft upstream from the bridge.

Arboleda Drive crossing Bear Creek looking upstream. Summer 2018

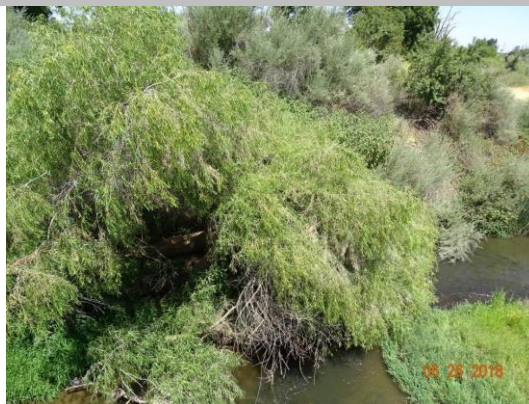
Photo 2 of 3 : CH_2018_NA0013_32_21_20180709_00028.jpg

Inspector Comments: There is growth in the channel and vegetation on the left bank upstream of crossing. Recommend clearing vegetation at least 100ft upstream from the bridge.

Arboleda Drive crossing Bear Creek looking upstream. Summer 2018

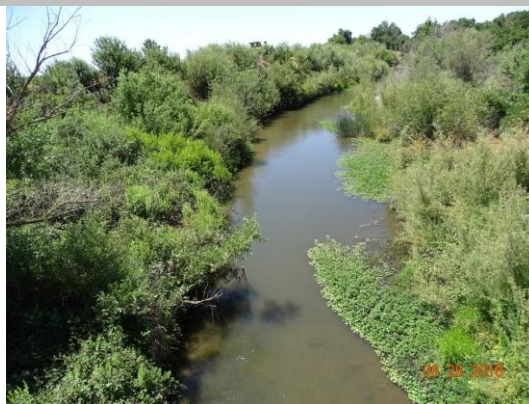
Photo 1 of 3 : CH_2018_NA0013_32_26_20180709_00031.jpg

Inspector Comments: There is vegetation present on both banks of crossing. Recommend clearing vegetation at least 100ft downstream from the bridge.

Arboleda Drive Bridge, crossing the Bear Creek looking downstream.
Summer 2018

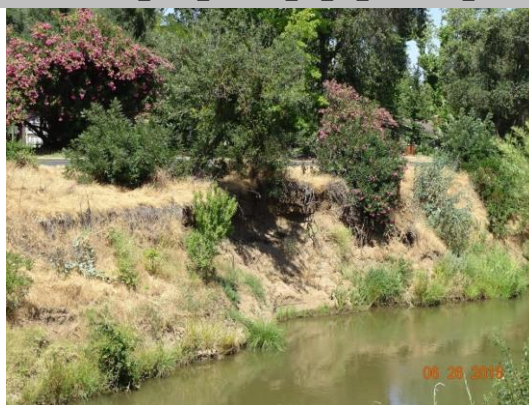
Photo 1 of 3 : CH_2018_NA0013_32_43_20180709_00046.jpg

Inspector Comments: Erosion still present on the right bank upstream of the McKee Rd. Bank should be repaired before Flood Season.

View of erosion on the right bank upstream of McKee Rd bridge.
Summer 2018

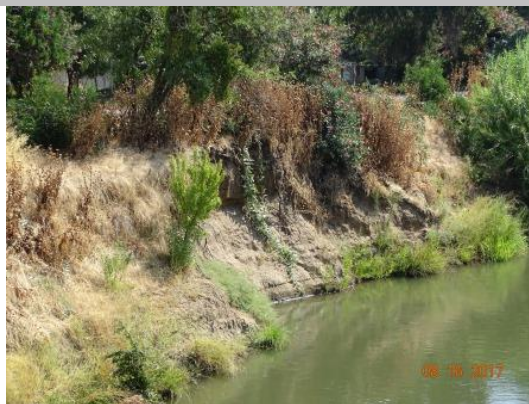
Photo 3 of 3 : CH_2018_NA0013_32_43_20180608_00011.jpg

Inspector Comments: Erosion still present on the right bank upstream of the McKee Rd. Bank should be repaired before Flood Season.

View of the erosion in the channel.

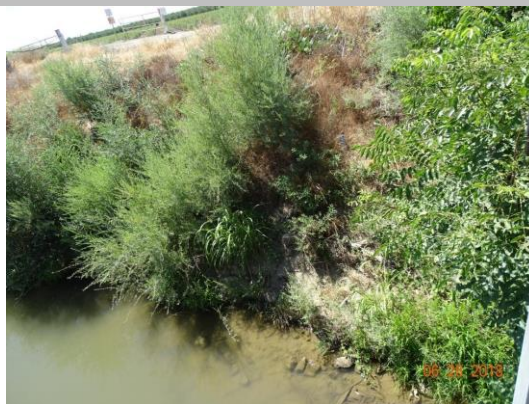
Photo 1 of 1 : CH_2018_NA0013_32_63_20180709_00054.jpg

Inspector Comments: Some erosion was observed at this location but does not appear to affect the channel capacity. Summer 2018

View of minor erosion upstream of Franklin Rd crossing, but it does not appear to endanger the channel capacity. Summer 2018

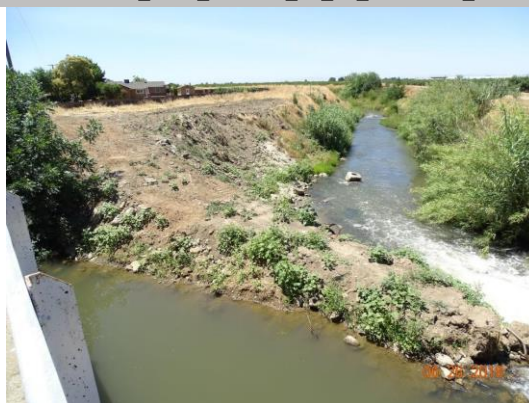
Photo 1 of 2 : CH_2018_NA0013_33_60_20180706_00044.jpg

Black Rascal Creek looking downstream from Quinley Rd. crossing.
Rock dam remains in channel. Summer 2018

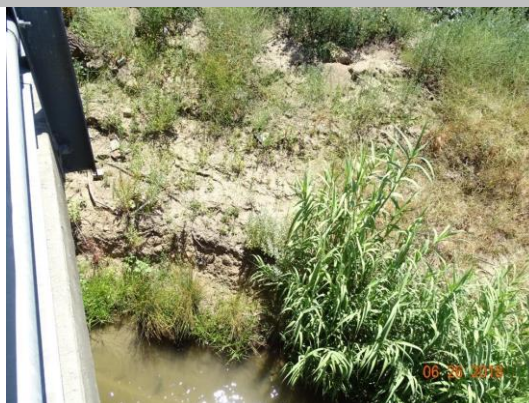
Photo 1 of 1 : CH_2018_NA0013_33_68_20180706_00049.jpg

Some erosion on left bank downstream of Oak Ave. crossing. Summer 2018

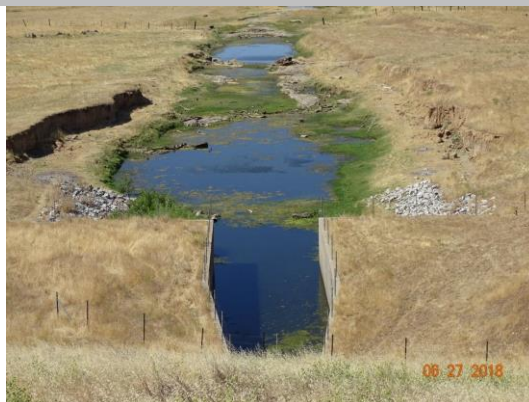
Photo 1 of 2 : CH_2018_NA0013_34_6_20180709_00010.jpg

View of vegetation at the Burns Creek Dam outlet. Summer 2018

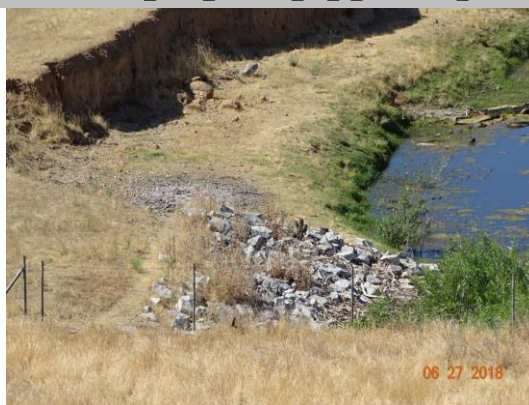
Photo 1 of 2 : CH_2018_NA0013_34_9_20180709_00008.jpg

View of revetment on left bank downstream of Burns Creek Dam.
Vegetation growing in riprap. Summer 2018

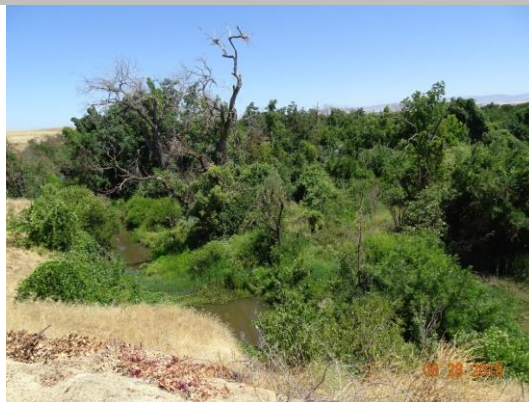
Photo 1 of 1 : CH_2018_NA0013_34_22_20180709_00013.jpg

View of shoal connecting banks of Burns Creek. Summer 2018

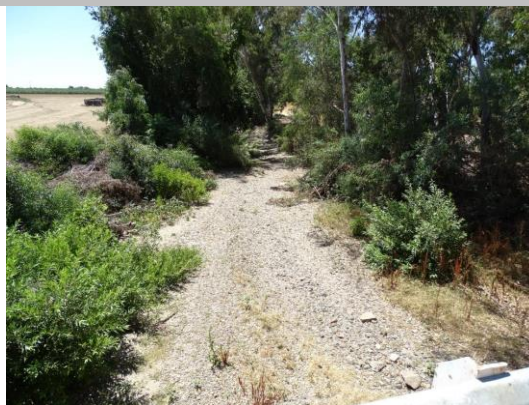
Photo 1 of 3 : CH_2018_NA0013_35_16_20180711_00053.jpg

View of vegetation in the channel. Summer 2018

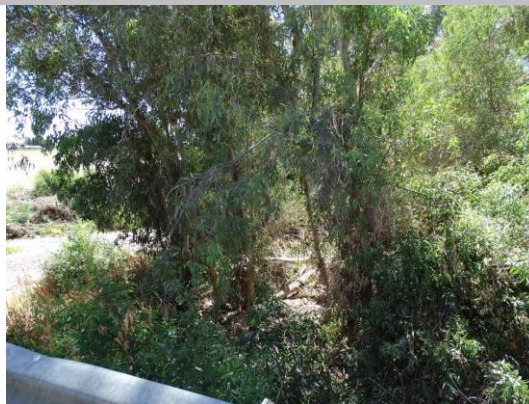
Photo 2 of 3 : CH_2018_NA0013_35_16_20180711_00054.jpg

View of vegetation along right bank. Summer 2018

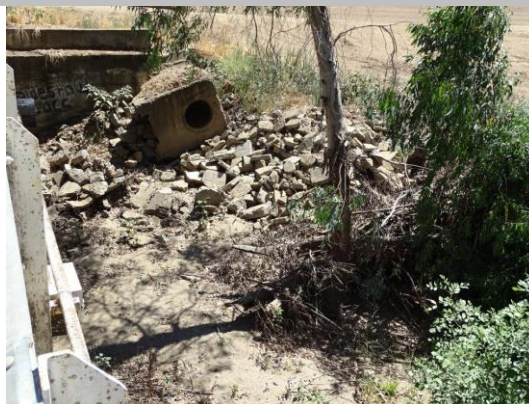
Photo 1 of 1 : CH_2018_NA0013_35_19_20180712_00098.jpg

View of broken concrete riprap on the left bank. Summer 2018

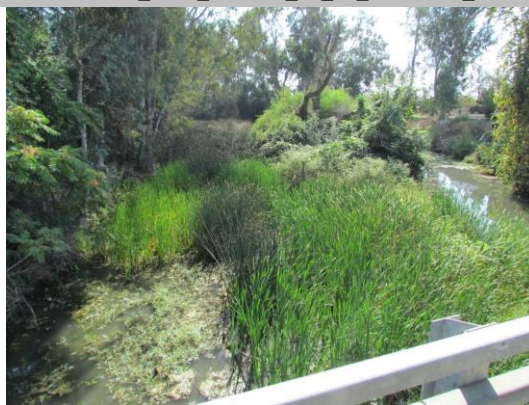
Photo 2 of 2 : CH_2018_NA0013_35_22_20180608_00008.jpg

There is shoaling and sedimentation present in channel and the flow has been impeded. Summer 2017

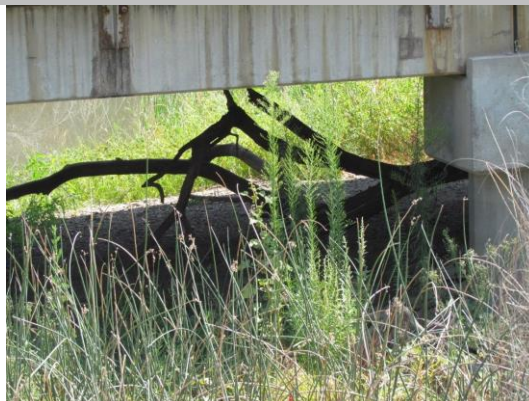
Photo 1 of 3 : CH_2018_NA0013_35_35_20180608_00011.jpg

Dead trees under the RR Bridge crossing left bank of the Mariposa Creek.

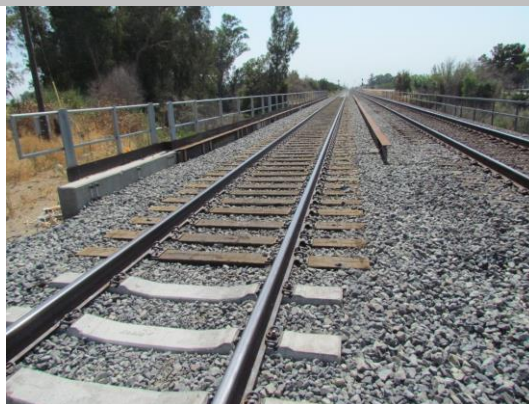
Photo 2 of 3 : CH_2018_NA0013_35_35_20180608_00012.jpg

New RR Bridge line crossing the Mariposa Creek without Authorization from CVFP Board.

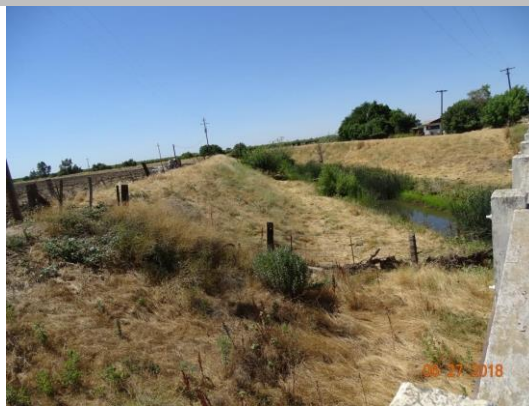
Photo 1 of 5 : CH_2018_NA0013_35_50_20180711_00066.jpg

View of wire fencing across left bank. Summer 2018

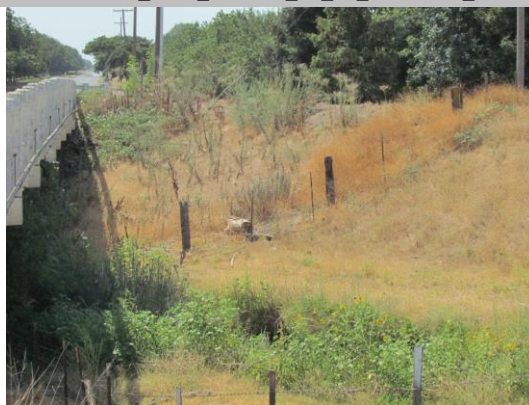
Photo 4 of 5 : CH_2018_NA0013_35_50_20180608_00017.jpg

Standing on the right bank of Mariposa Creek wire fence present on the left bank extending under bridge. Summer 2017

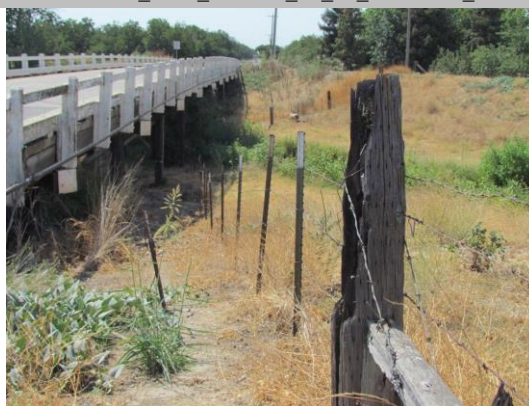
Photo 5 of 5 : CH_2018_NA0013_35_50_20180608_00018.jpg

This picture shows the wire fencing continues up the right bank downstream of bridge. It runs across the channel. Summer 2017

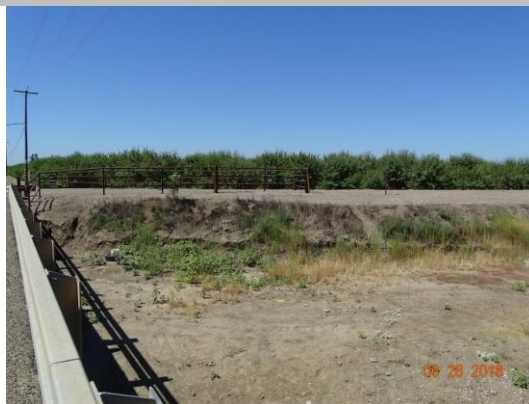
Photo 1 of 2 : CH_2018_NA0013_35_58_20180711_00071.jpg

View of erosion along left bank. Summer 2018

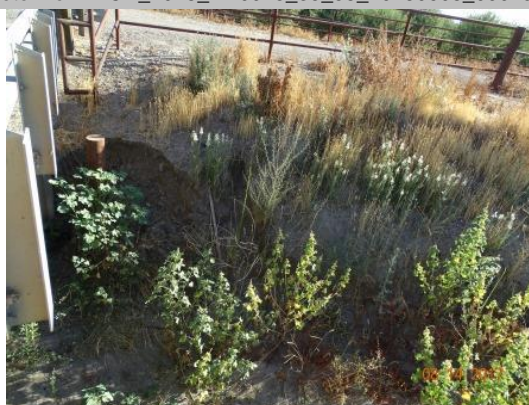
Photo 2 of 2 : CH_2018_NA0013_35_58_20180608_00023.jpg

View of the erosion of the channel bank. Summer 2017

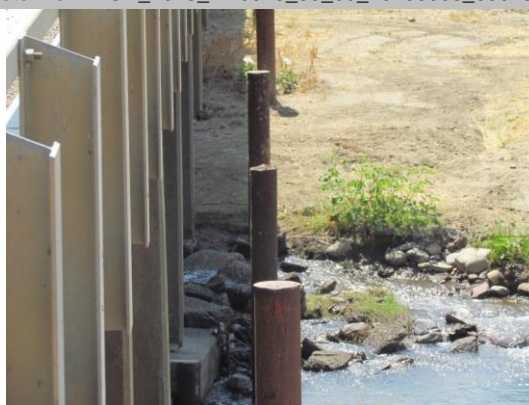
Photo 2 of 2 : CH_2018_NA0013_35_60_20180608_00025.jpg

Another view of the metal post installed across the channel viewed from the right bank. Summer 2017

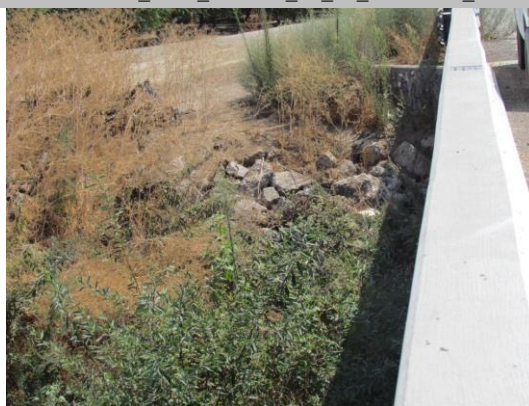
Photo 4 of 4 : CH_2018_NA0013_35_74_20180608_00031.jpg

Looking at left bank of Mariposa Creek the riprap revetment is visible through the wild growth. Summer 2017

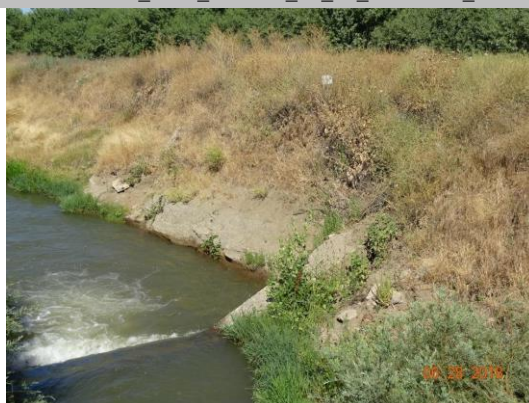
Photo 1 of 5 : CH_2018_NA0013_35_78_20180712_00082.jpg

View of erosion on the right bank. Summer 2018

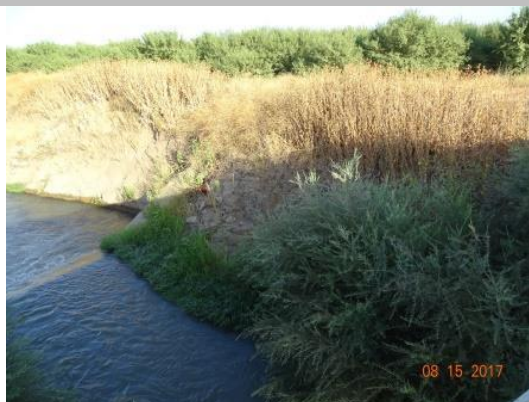
Photo 2 of 5 : CH_2018_NA0013_35_78_20180608_00033.jpg

View of the erosion on the right bank. Summer 2017

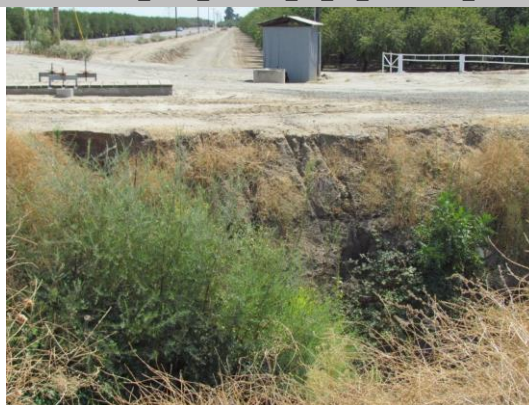
Photo 3 of 5 : CH_2018_NA0013_35_78_20180608_00034.jpg

Looking from the right bank downstream of erosion on the left bank.

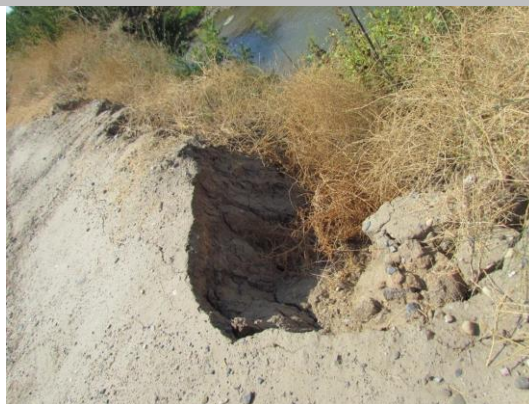
Photo 5 of 5 : CH_2018_NA0013_35_78_20180608_00036.jpg

Looking from left bank at the erosion.

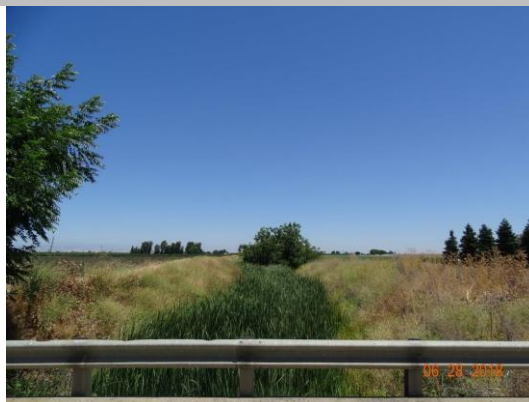
Photo 1 of 2 : CH_2018_NA0013_36_41_20180712_00044.jpg

View of vegetation in the channel. Summer 2018

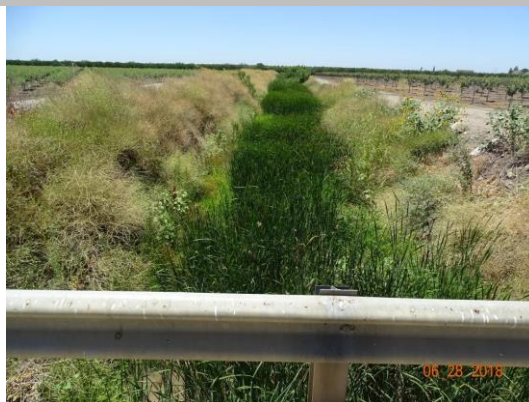
Photo 1 of 1 : CH_2018_NA0013_36_46_20180712_00045.jpg

View of vegetation in the channel. Summer 2018

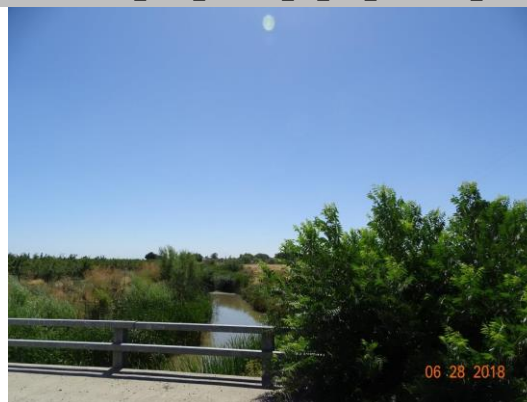
Photo 1 of 3 : CH_2018_NA0013_36_116_20180713_00074.jpg

View of vegetation in the channel. Summer 2018

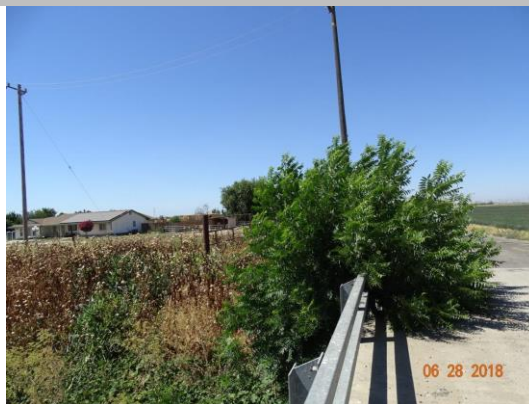
Photo 2 of 3 : CH_2018_NA0013_36_116_20180713_00075.jpg

View of brush growing over the bridge. Summer 2018

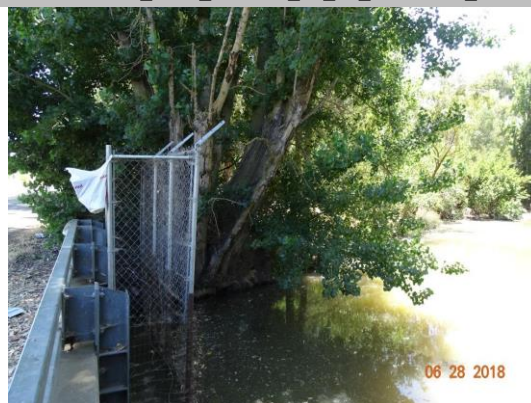
Photo 1 of 2 : CH_2018_NA0013_36_90_20180712_00062.jpg

View of wire fencing on left bank. Summer 2018

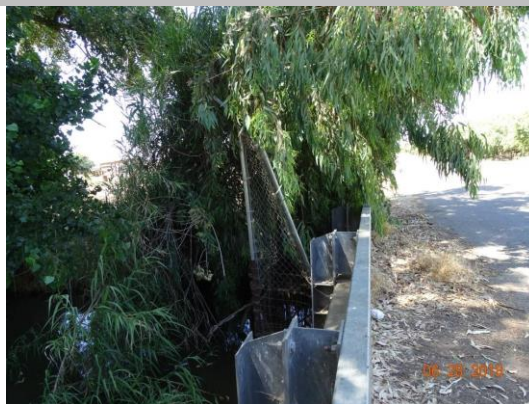
Photo 2 of 2 : CH_2018_NA0013_36_90_20180712_00061.jpg

View of wire fencing on right bank. Summer 2018

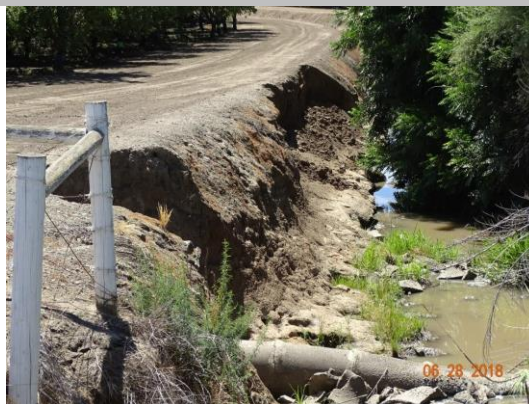
Photo 1 of 3 : CH_2018_NA0013_36_108_20180713_00069.jpg

View of erosion on the left bank. Summer 2018
